**Massey Hall
Roof Repair & Replacement
The University of Tennessee
Knoxville, Tennessee**

Roof Replace/Restore	17,015 s.f.
Construction Cost	\$285,380
Cost/s.f.	\$16.77
Parapet Wall Rebuild	\$158,620
Completion Date	2011

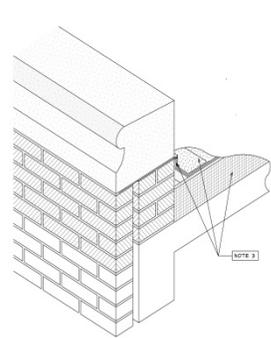
Existing Parapet Wall

An on-site meeting and further investigation of the roof was conducted by Architects Weeks Ambrose McDonald, the roofing manufacturer, and with University personnel. The investigation revealed that the existing parapet thru-wall flashing had been installed too low to the roof and ponded water could possibly enter into the roof system around the perimeter of the building. Other issues identified during the investigation included: improperly flashed overflow scuppers, blistering of the roof membrane, open 'fishmouth' laps, loose metal counterflashings, membrane granule loss, and open masonry joints around the elevator/stair penthouses.

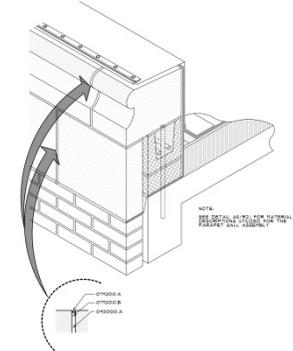
New Parapet Wall Rebuild

The scope of work identified for the roof replacement included a complete roof system tear-off and replacing it with a new cold-applied 2-ply SBS modified bitumen roof with new tapered insulation. Additional work identified in the construction documents included a total rebuild of the perimeter parapet wall, refurbishing rooftop equipment, new prefinished metal flashings, conductor heads/downspouts, repointing penthouse masonry joints, and installing metal wall panels around the steam room penthouse.

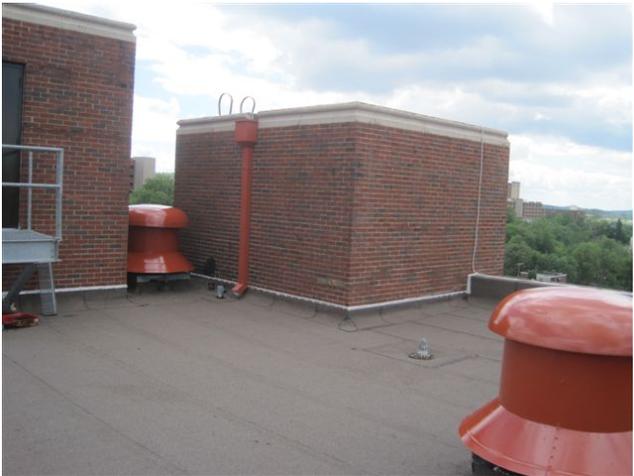
The New 2-Ply Modified Bitumen Roof System (Leak Free)
