Greve Hall Roof Repair & Replacement The University of Tennessee Knoxville, Tennessee

Roof Replace/Restore	15,614 s.f.
Construction Cost	\$197,000
Cost/s.f.	\$12.62
Completion Date	2014

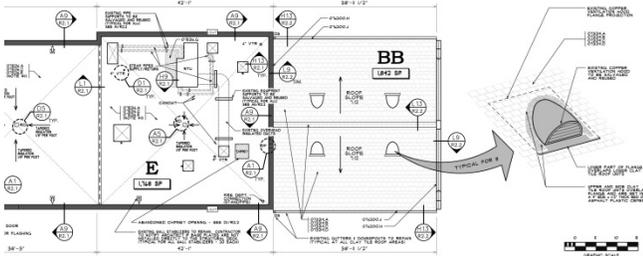
Before

Greve Hall is one of the older residence halls that had recently been converted into a 'surge' space building for the University. The building is used primarily as a temporary facility for administrative offices and classrooms while other building renovations take place around the UTK campus. Greve Hall is a 7-story "high-rise" structure with sloping gable clay tile roofs on the north and south sides of the building. Adjacent low-slope roof areas and the penthouse stair structures continued to leak after minor renovations and the building occupants demanded corrective action.

The scope of work included a complete roof system tear-off of the existing EPDM ballasted membrane roof on the north/south and penthouse low-sloped roof areas, as well as the plaza paver roof and replacing it with a new cold-applied 2-ply SBS modified bitumen roof with new tapered insulation.
