**Lenoir City Elementary School  
Roof Replacement  
Lenoir City Schools  
Lenoir City, Tennessee**

Lenoir City Elem. Roof 67,392 s.f.  
Construction Cost \$200,015  
Cost/s.f. \$2.97  
Completion Date 2008

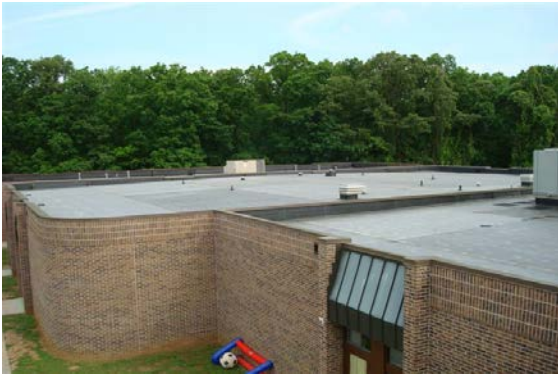
Lenoir City Elementary had an existing ballasted EPDM roof installed that was difficult to maintain by the school system maintenance department and they also had a problematic rooftop air handling unit that contributed to the reported roof leaks in the building.

Existing Ballasted EPDM

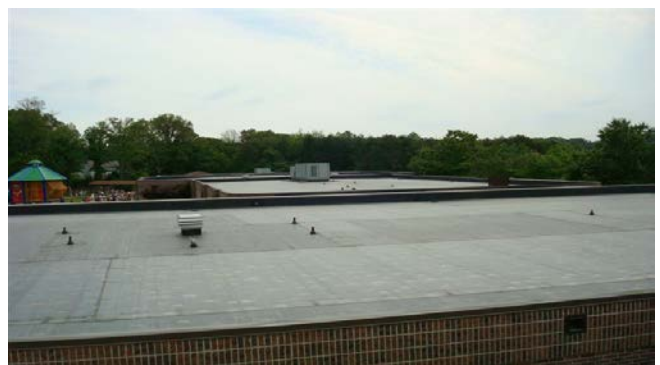
New Fully Adhered 60 Mil Thick EPDM Roof

The roof replacement consisted of removing the existing rock ballast and 45 mils thick EPDM membrane, removing/replacing portions of the existing insulation found to be wet or unserviceable, installing a high density coverboard over the existing insulation, attaching the insulation composite to the roof deck, and installing a 60 mils thick fully adhered EPDM membrane for a 20-year roof guarantee. All new metal coping and metal flashings were installed throughout and the problematic rooftop air handling unit was repaired at the condensation pan.
