**Fleming Warehouse
Roof Repair & Replacement
The University of Tennessee
Knoxville, Tennessee**

Roof Replace (East)	95,218 s.f.
Roof Restore (West)	98,371 s.f.
Construction Cost	\$1,483,734
Cost/s.f.	\$7.66
Completion Date	2014

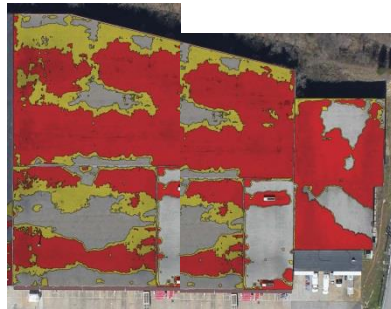
West End

The west end of the warehouse was bid as an acceptable alternate and this work consisted of repairing the existing EPDM membrane lap splices at all locations, replacing the existing roof edge metal with new metal fascia anchored to meet wind uplift requirements, and venting the remaining moisture from the existing roof insulation.

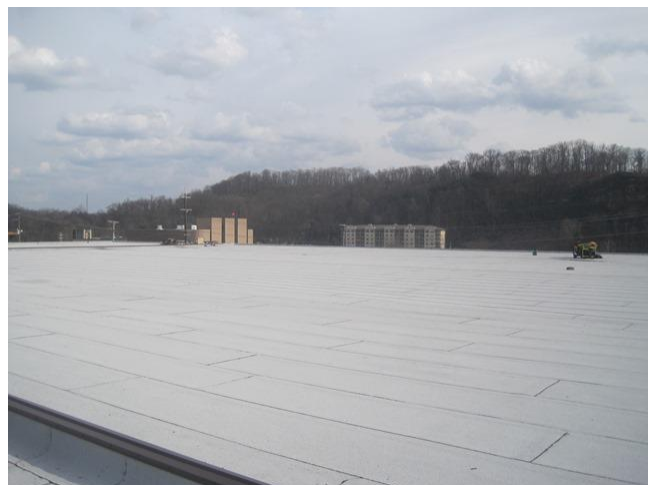
Fleming Warehouse – New Roof (East End)

The scope of work identified in the base bid included a complete roof system tear-off of the existing 4-ply built-up roof on the east end of the warehouse and replacing it with a new cold-applied 2-ply SBS modified bitumen roof with new tapered insulation. Additional work identified in the base bid included damaged deck replacement, abandoned equipment removal, CMU repairs, new metal siding, new metal fascia, new gutters/downspouts, new wall mounted ladders, and painting of the loading dock canopies.
